George Washington Memorial Parkway Traffic and Safety Context Sensitive Solutions Assessment

APRIL 2021

1. REPORT DATE • 7/31/2020	2. REPORT TYPE Final Report	3. DATES COVERED (<i>From - To</i>) November 2018 - July 2020	
4. TITLE AND SUBTITLE George Washington Memorial Parkway: Traffic and Safety Context Sensitive Solutions Assessment		5a. CONTRACT NUMBER DTFH71-13-D-00002L	
		5b. GRANT NUMBER: Task Order 693C7319F000010	
		5c. PROGRAM ELEMENT NUMBER

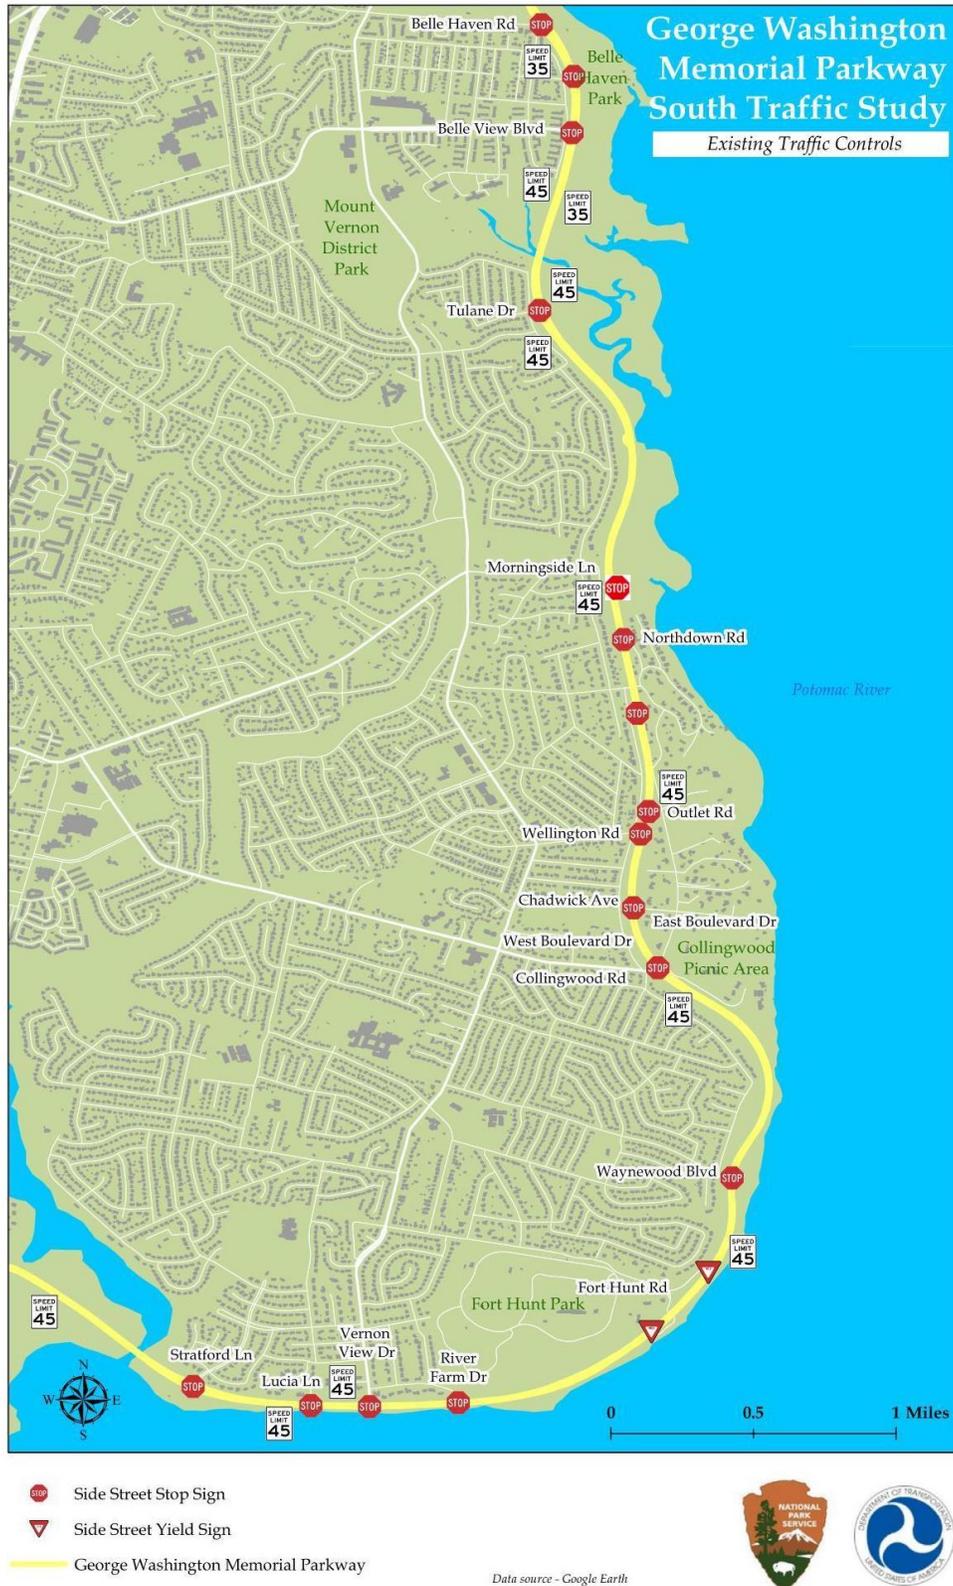
Figure 2. Study Corridor: Traffic Controls and Speed Limits

Figure 2 shows the study area map with the traffic control from each approach and posted speed limits identified.

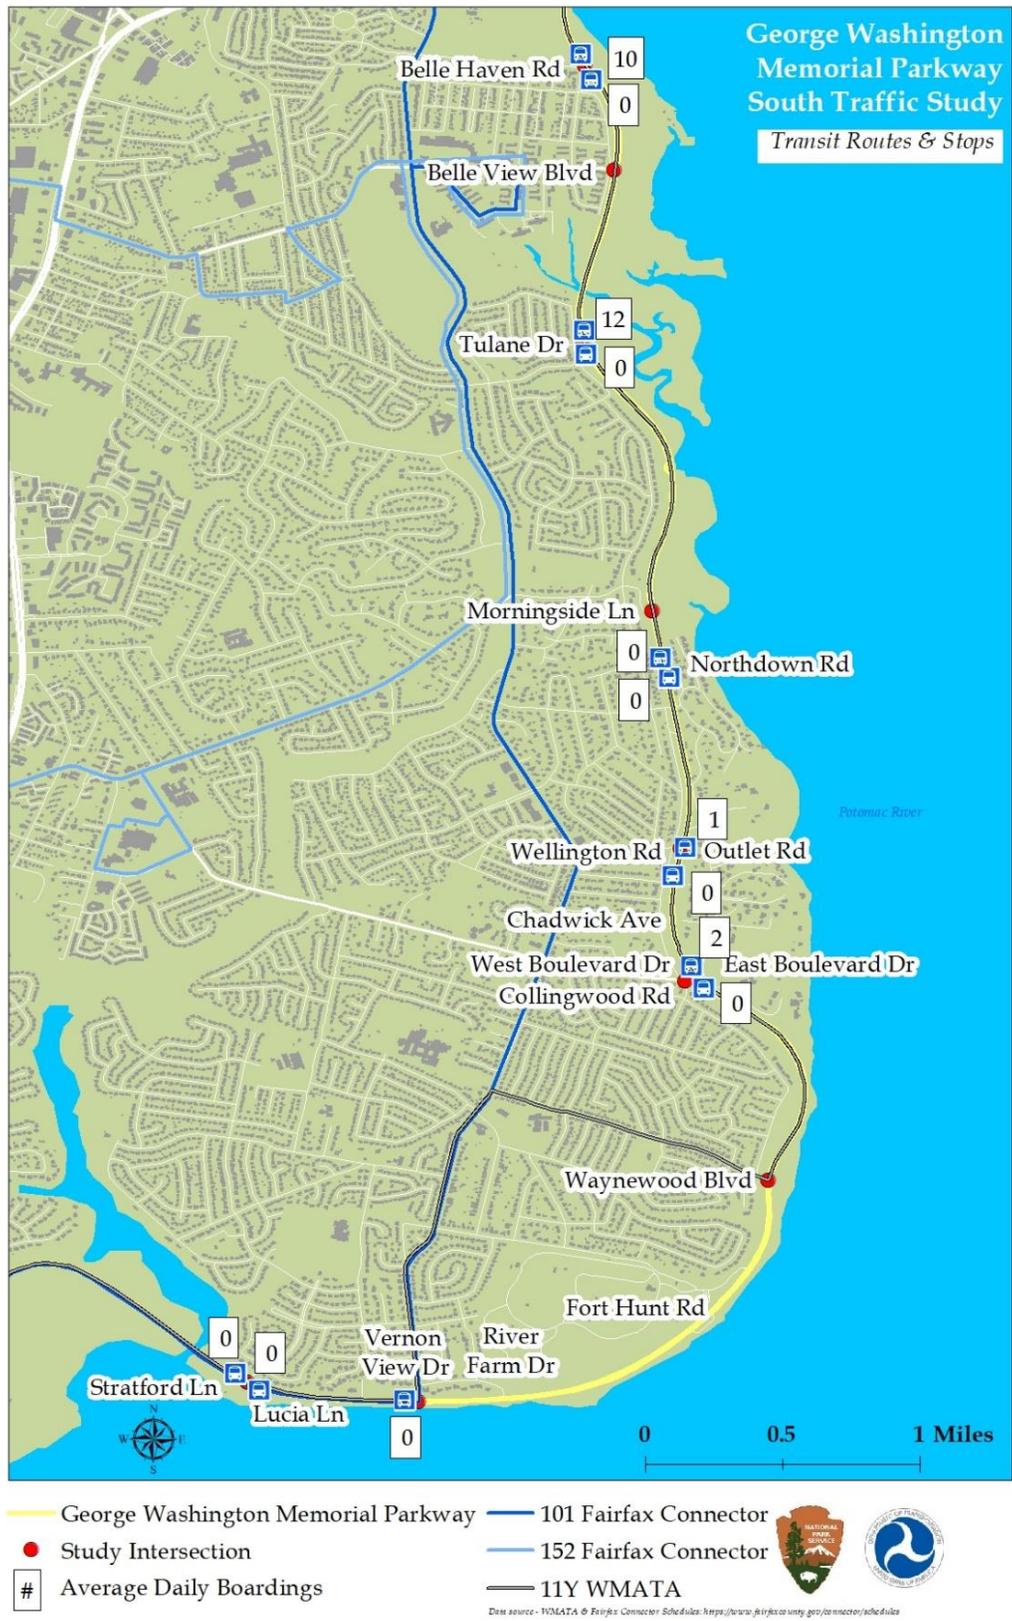
Figure 5. Existing Transit Routes, Stops, and Daily Boardings

As shown in Table 2, pedestrian and bicycle traffic volumes were higher in the p.m. peak hour than in the morning peak hour. The data collection counted more than 600 combined pedestrians and bicyclists at the locations along the Mount Vernon Trail during the 12-hour study. For further information about trail conditions, safety concerns, and maintenance needs and opportunities, please reference [Mount Vernon Trail Corridor Study: George Washington Memorial Parkway](#) (Daddio, et al. 2019). Figure 4 illustrates the existing pedestrian and bicycle network including the Mount Vernon Trail, and Figure 5 illustrates the existing transit routes, stops, and daily boardings.

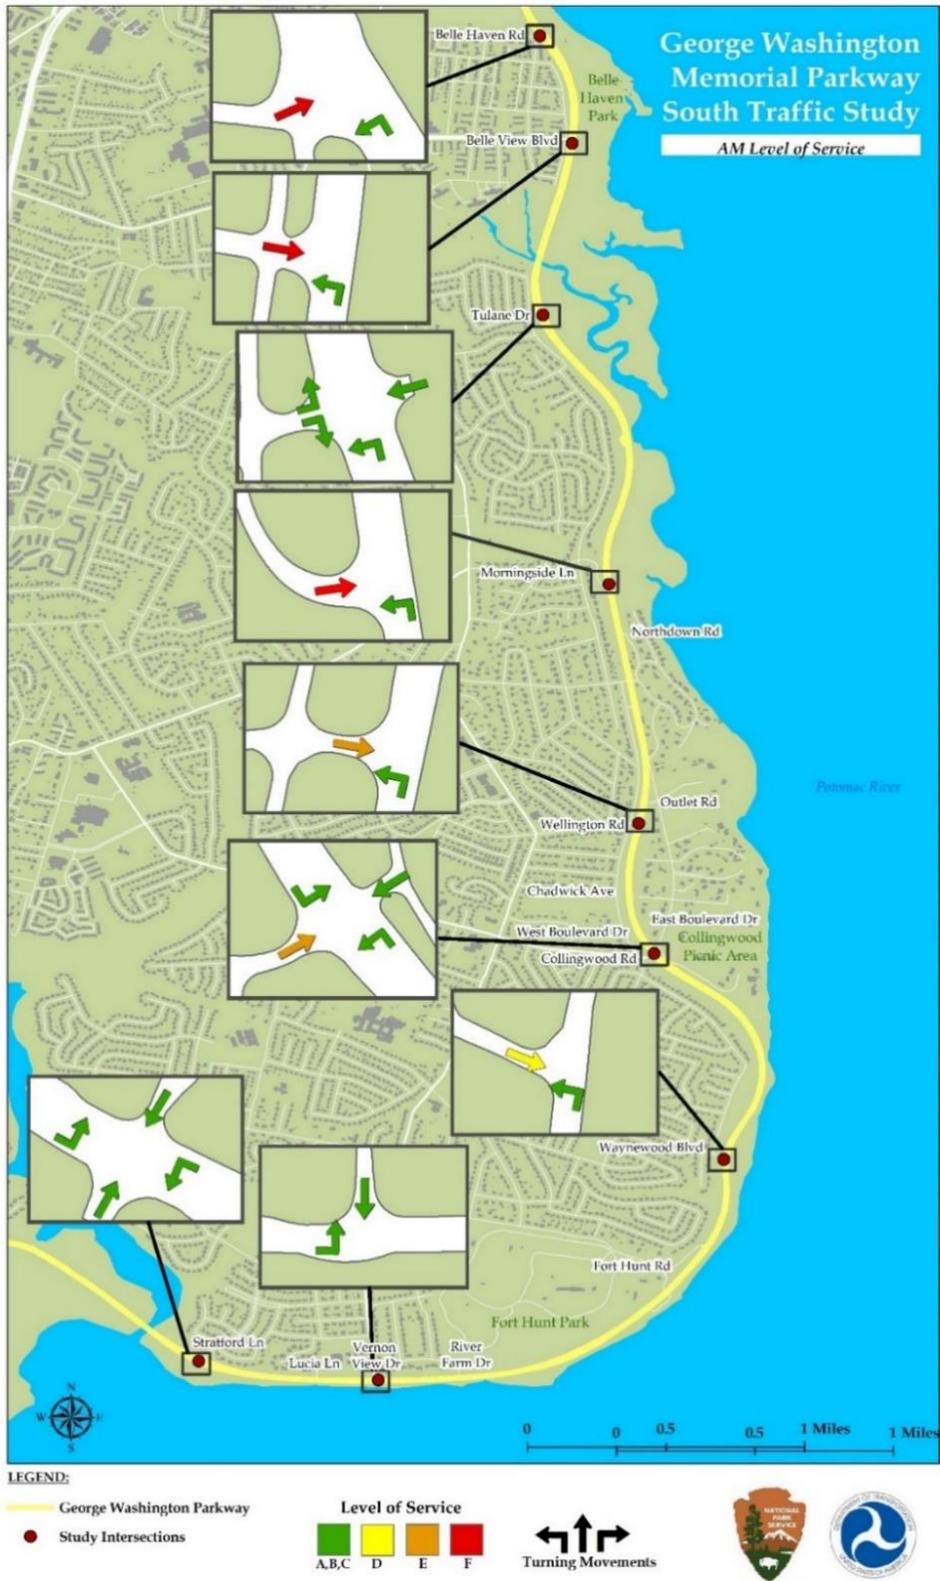
Figure 7. A.M. Peak Level of Service per Lane at Study Intersections

Delay (control delay) is the portion of delay attributed to traffic signal operation for signalized intersections or stop/yield signs for stop or roundabout-controlled intersections. Control delay (overall delay) is categorized into deceleration delay, stopped delay, and acceleration delay. Figure 7 and Figure 8 show the LOS for each movement at each study intersection on a map view for a.m. peak and p.m. peak, respectively. During the a.m. peak (shown in Figure 7. A.M. Peak Level of Service per Lane at Study Intersections), the approach from Belle Haven Road, Belle View Boulevard, and Morningside Lane all experienced a LOS F. Wellington Road and eastbound Collingwood Road experienced a LOS E. The Waynewood Boulevard approach experienced a LOS D. During the p.m. peak (shown in Figure 8), the situation became more congested at Belle Haven Road, with the left turn from the Parkway to Belle Haven Road experiencing an LOS F. The Belle View Boulevard and Morningside Lane approaches remained consistent in the p.m. peak to that in the a.m. peak, with a LOS F. The Wellington Road, eastbound Collingwood Road, and Waynewood Boulevard approaches all improved during the p.m. peak, with an LOS D; LOS A, B, C; and LOS A, B, C, respectively.

- Belle Haven Road — LOS F during a.m. and p.m. peak hour
- Belle View Boulevard — LOS F during a.m. and p.m. peak hour
- Morningside Lane — LOS F during a.m. and p.m. peak hour
- Collingwood Road — LOS E during a.m. peak hour

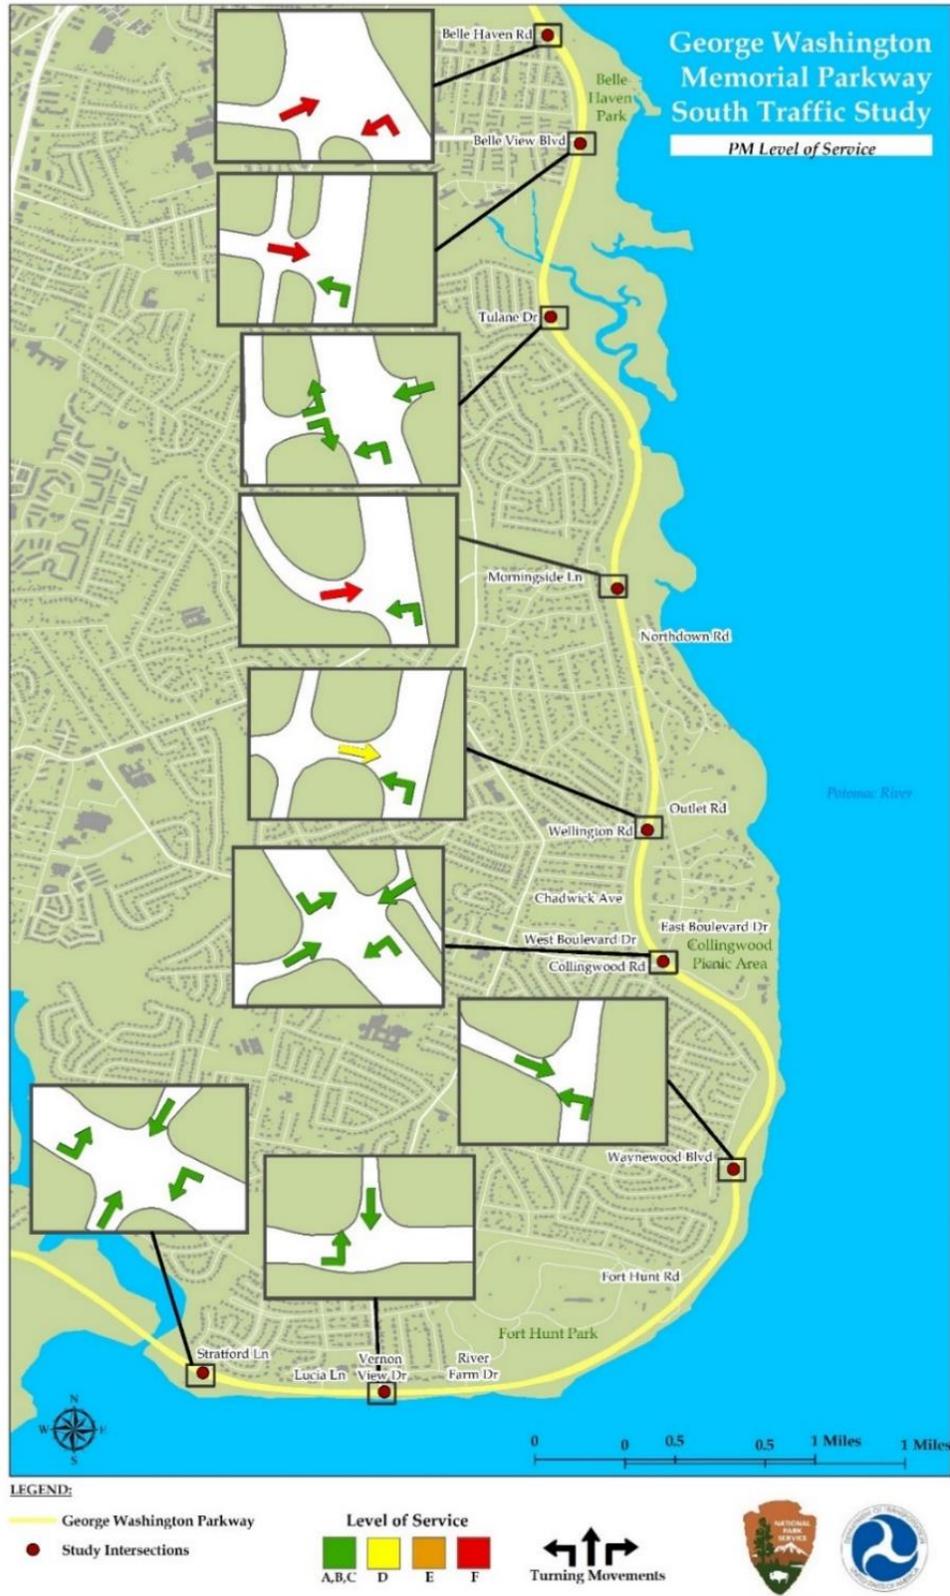
Figure 8. P.M. Peak Level of Service per Lane at Study Intersections

Many of the intersections in the northern portion of the study corridor have an approach that experiences high vehicle delays. As an example, eastbound Belle View Boulevard experienced 95.4 seconds of Average Delay per Approach Vehicle in the p.m. peak hour (see the red arrow to the right in Figure 8 at the Belle View Boulevard intersection). A delay of 95 seconds for a stop sign-controlled approach is considered excessive based on the *Highway Capacity Manual*, which grades delays of greater than 50 seconds (about half of what drivers approaching the Parkway on Belle View Boulevard experience) as failing LOS for stop signs. Lowering the delay threshold can help reduce the variability in waiting time that motorists currently experience at stop signs when trying to find an adequate gap to safely enter traffic.

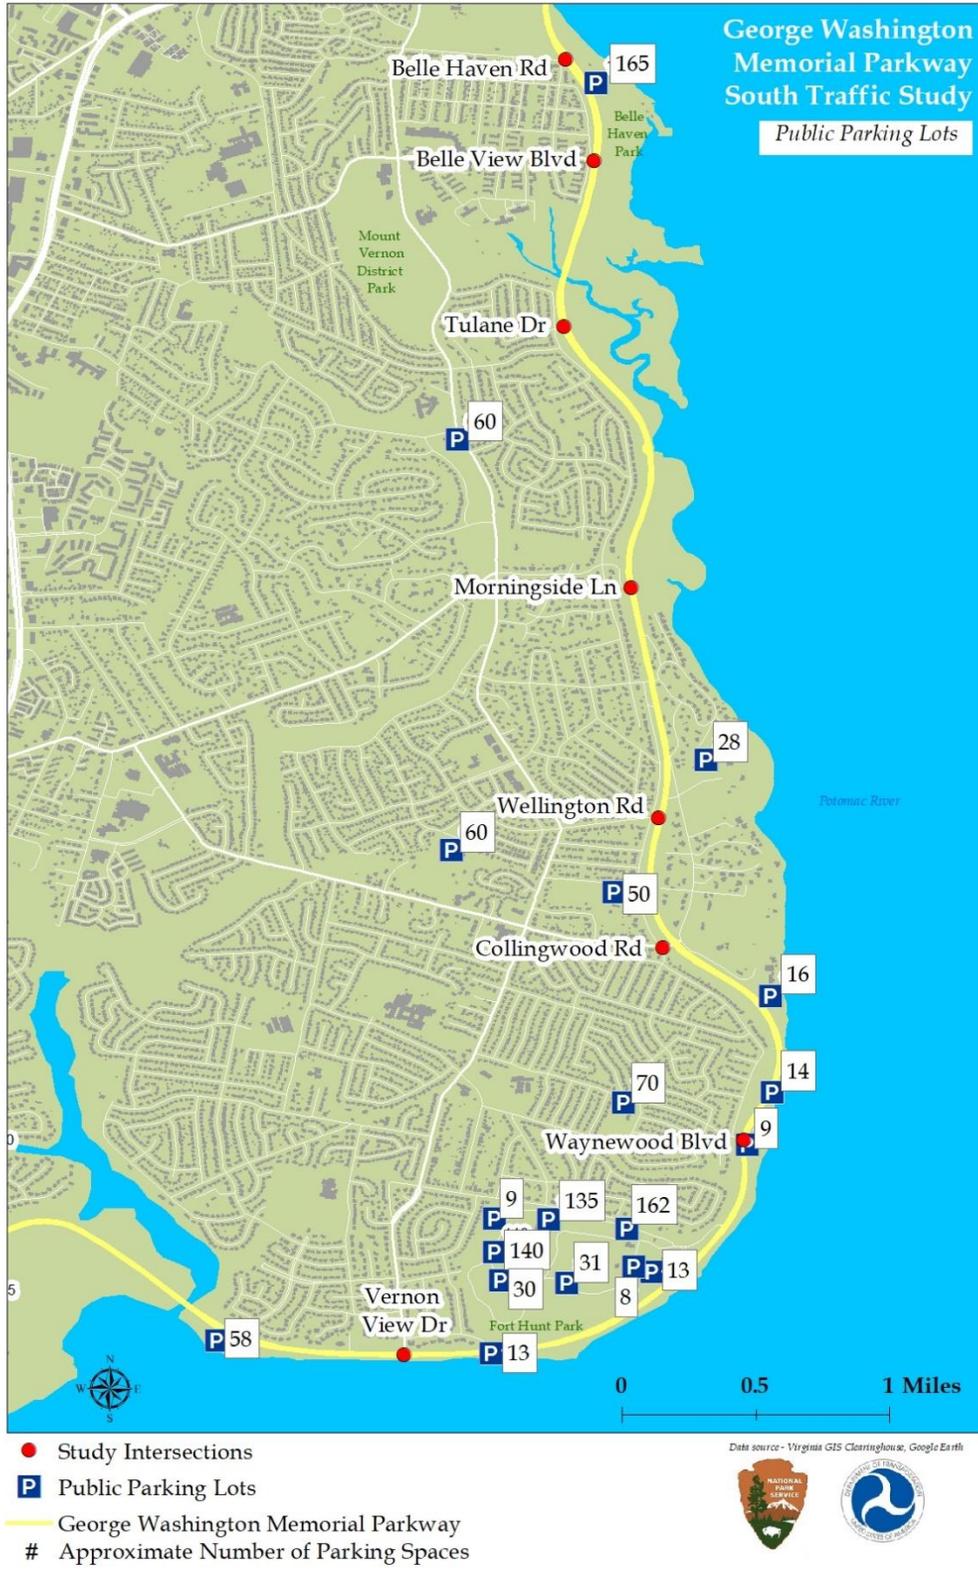
Figure 11. Existing Parking Lots

Parking Lot Description	Number of Spaces	Number of Spaces Filled		
		a.m. Peak	Midday	p.m. Peak
Belle Haven Road	165	10	57	43
East of the Parkway, American Horticultural Society at River Farm, north of Wellington Road	28	0	21 in lot 5 on road	6 in lot 5 on road
East of the Parkway, Collingwood Picnic Area	16	0	0	5
East side of the Parkway, north of Waynewood Boulevard	14	0	1	0
East side of the Parkway, at Waynewood Boulevard	9	0	0	1
Stratford Lane	58	5	33	20

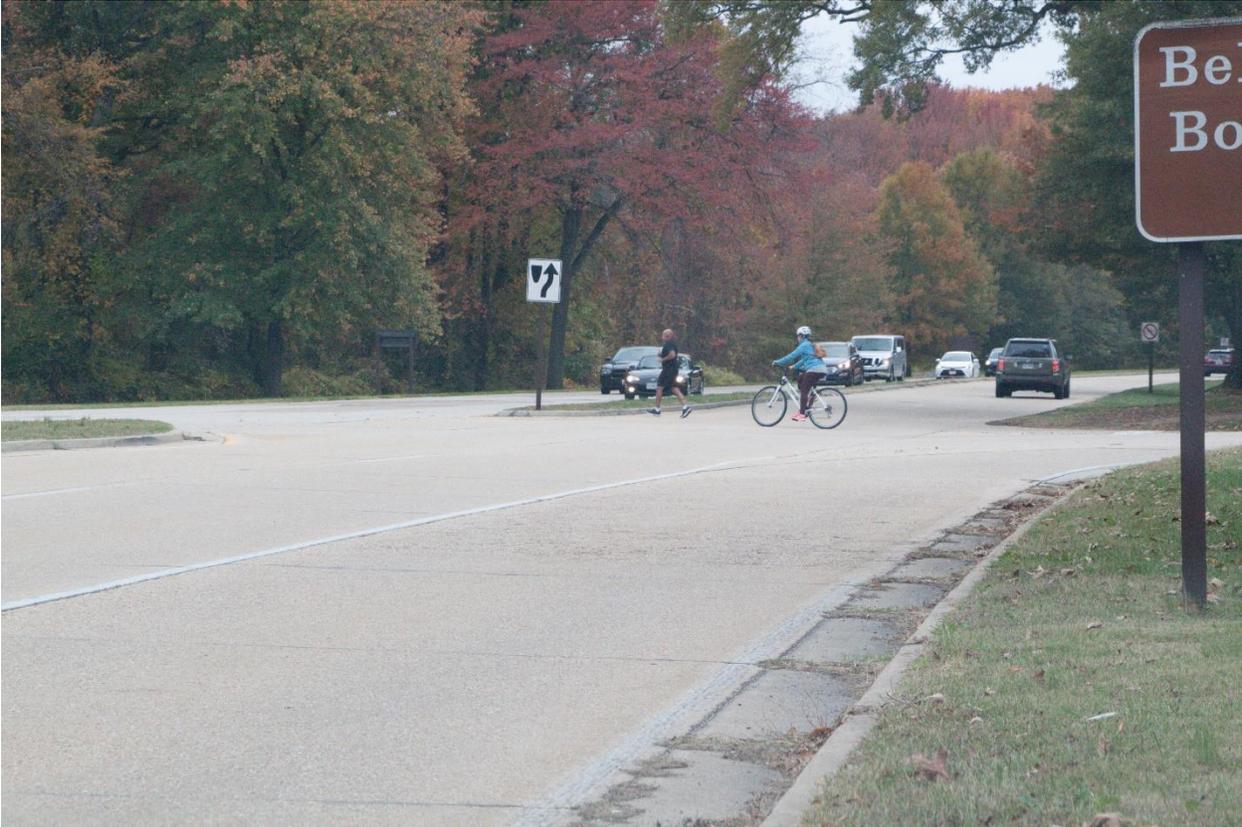
Figure 28. Pedestrian, Bicyclist, and Vehicle at the Parkway and Belle View Boulevard

Figure 28 shows one of many photos taken of pedestrians/bicyclists at this intersection. Finally, in the southbound direction of the Parkway, there is a right-turn lane. This lane can potentially obstruct a driver's view when looking to turn northbound from eastbound on Belle View Boulevard. In addition, there is the potential for confusion if someone in the right-turn lane does not commit to turning right.

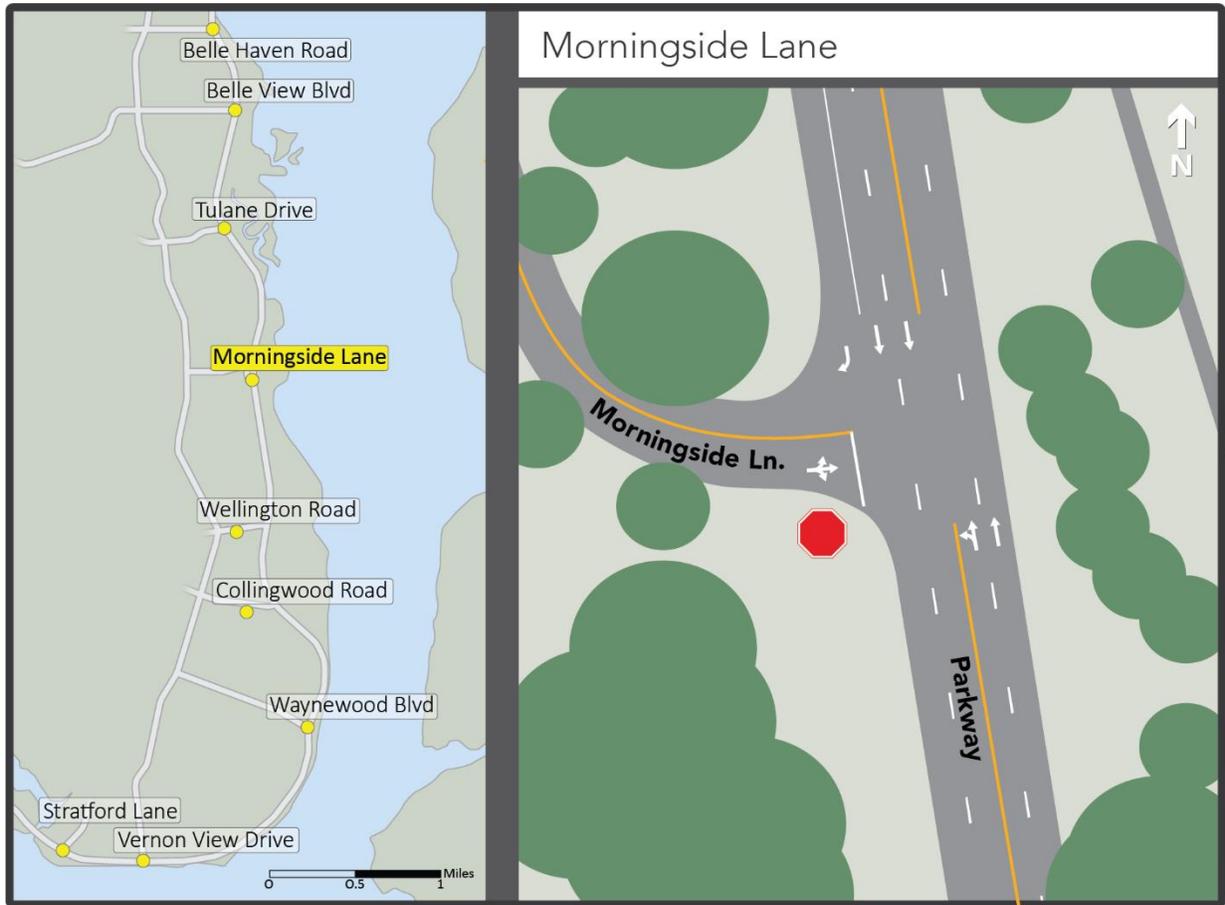
Figure 58. The Parkway and Morningside Lane

The Parkway and Morningside Lane is a three-legged intersection, with a horizontal and vertical curve along Morningside Lane (Figure 58).

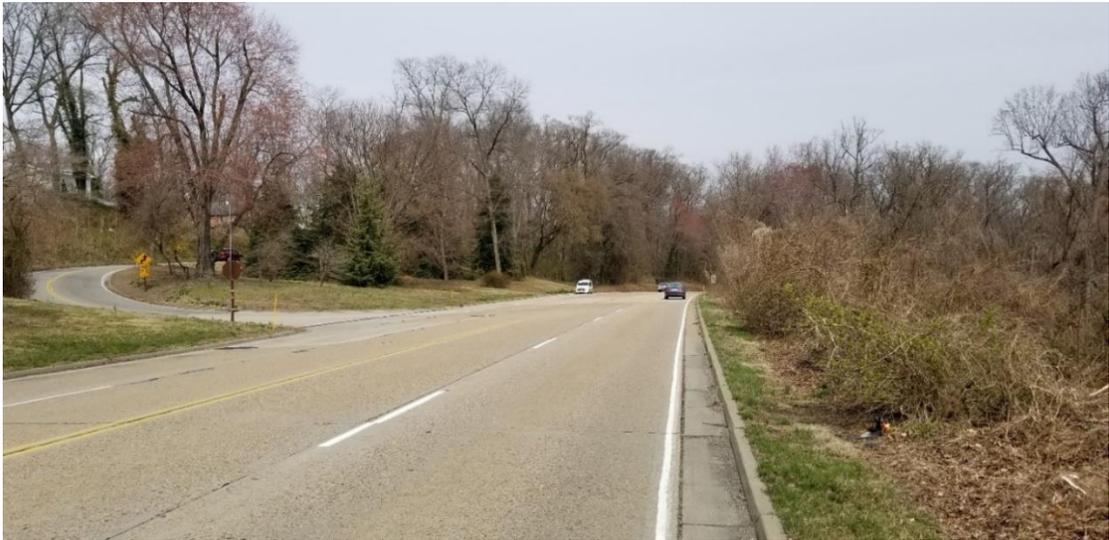
Figure 59. The Parkway and Morningside Lane, Looking North

Morningside Lane is stop-controlled. Morningside Lane itself seems to be slightly down-sloped (Figure 59); there is a right-turn lane in the southbound direction on the Parkway turning onto Morningside Lane (Figure 60).

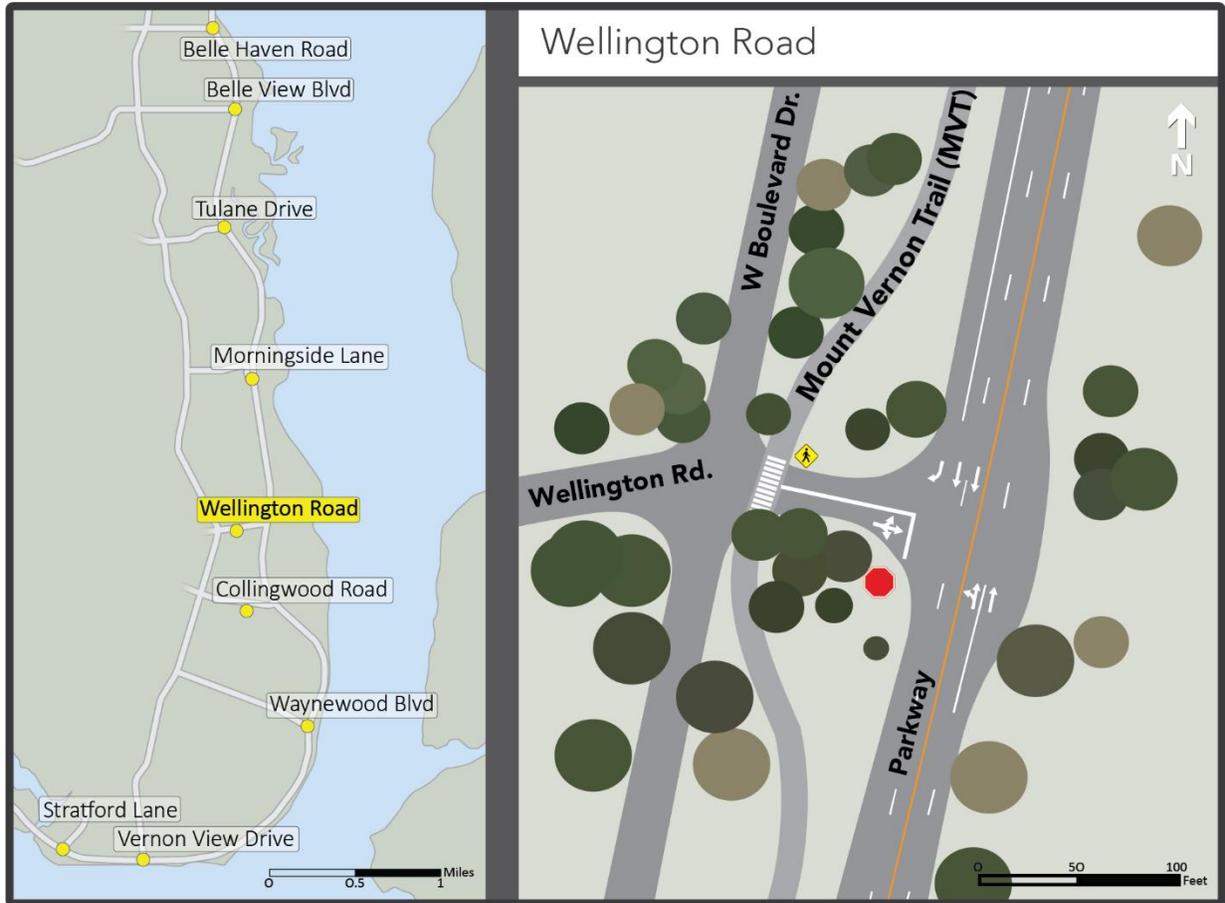
Figure 75. The Parkway and Wellington Road

Figure 75 shows the orientation of the Parkway and Wellington Road, a three-legged intersection.

Notice the close proximity between the Parkway and the parallel roadway (West Boulevard Drive) and to the Mount Vernon Trail. There is no advance warning to motorists traveling southbound and turning right that the trail crossing is present. A pedestrian warning sign (W11-2 from the *Manual on Uniform Traffic Control Devices* (USDOT/FHWA 2017)) is just east of the crossing.

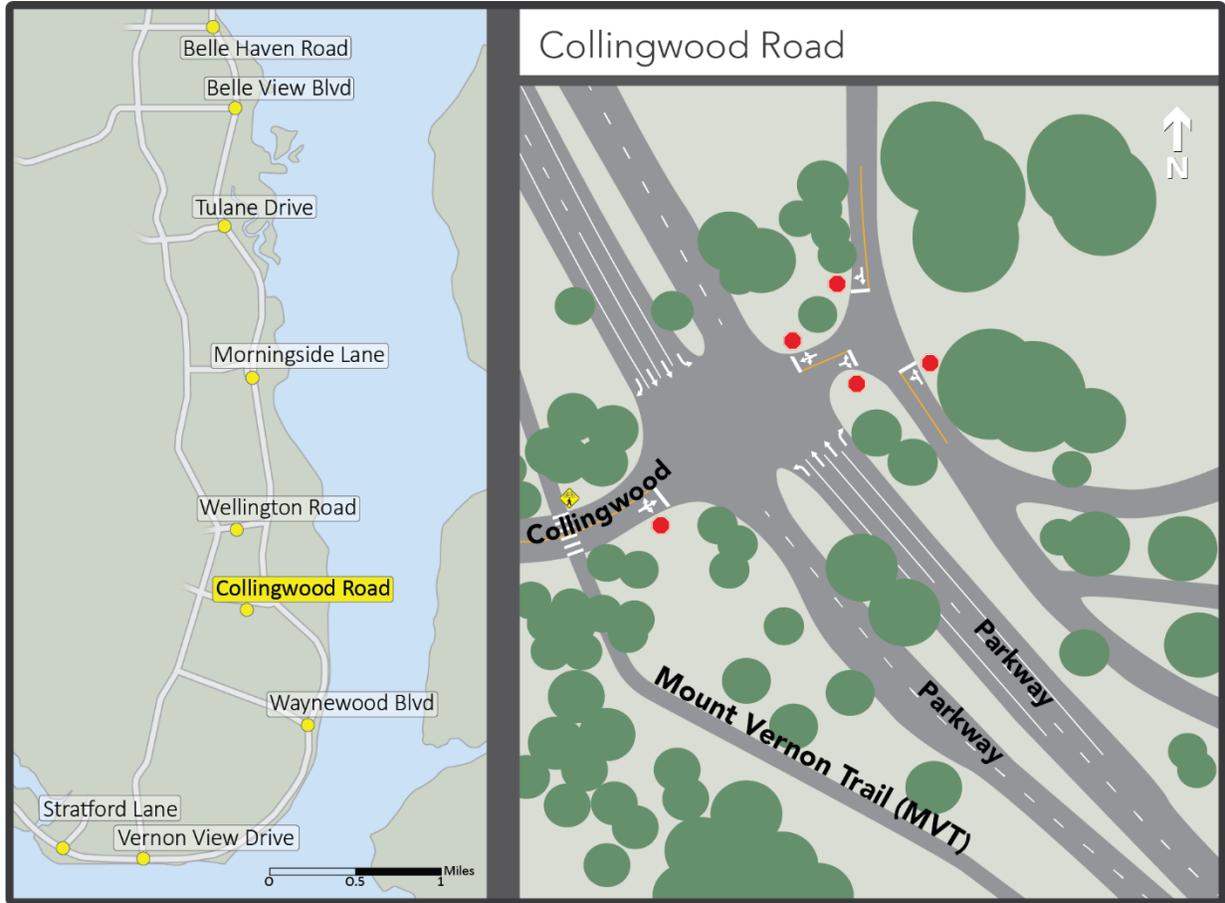
Figure 90. Intersection of the Parkway and Collingwood Road

Figure 90 shows the orientation of the Parkway and Collingwood Road, a four-legged intersection with a median.

There are a few interesting geometric considerations at this intersection. First, there is an intersection in close proximity to the main one on either side of the Parkway and Collingwood Road intersection and along with the MVT crossing on the south leg. The intersection to the northeast is Collingwood Road and East Boulevard Drive and the intersection to the southwest is Collingwood Road and West Boulevard Drive.

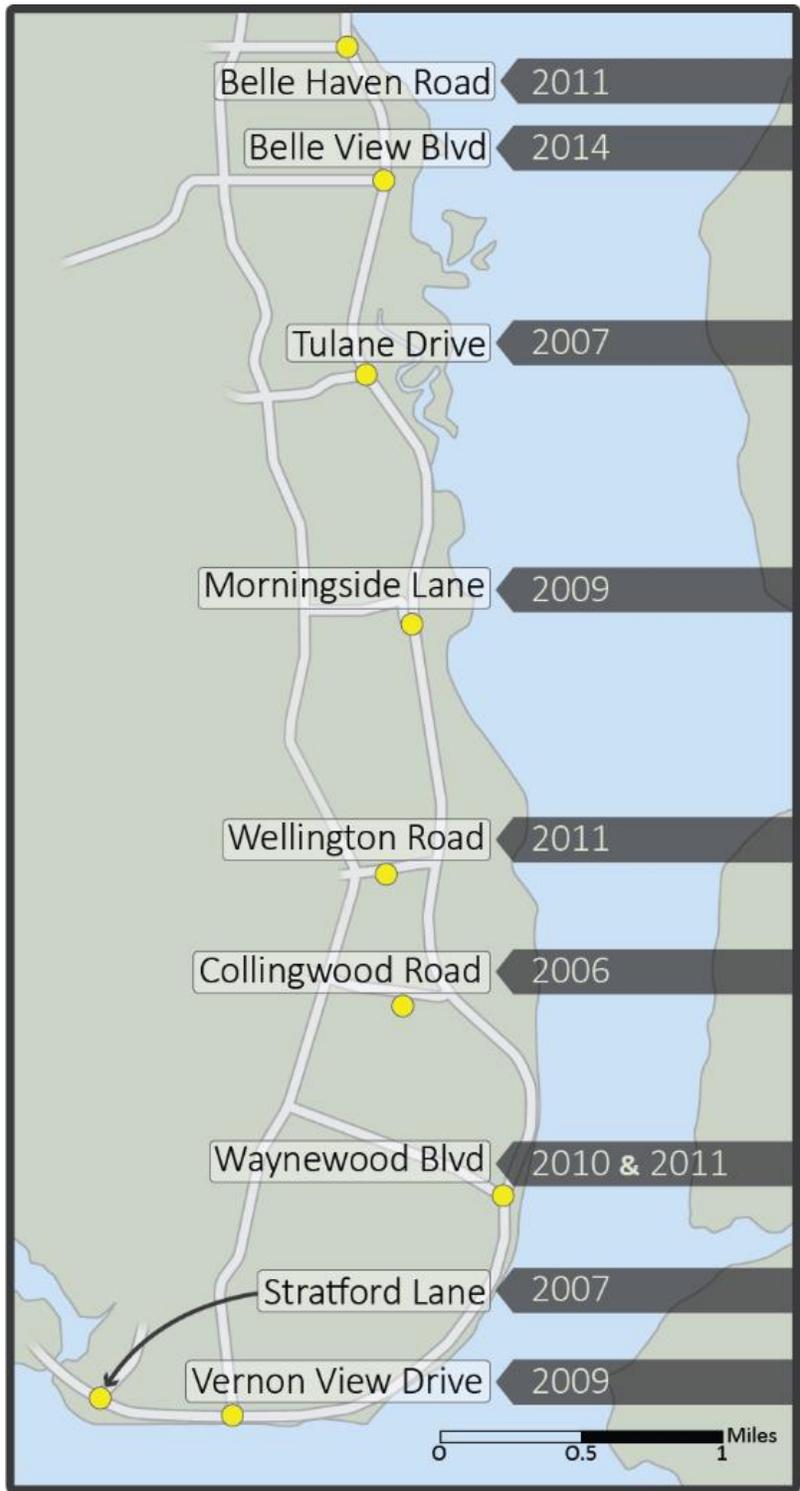
Figure 152. The South Parkway Corridor, Year of Most Frequent Crashes

Therefore, overall, it appears that accidents most likely occur during the peak periods in the morning and the afternoon rush when traffic numbers are higher. The year with the most crashes at these intersections was 2011 (Figure 152). However, as suggested by the number of

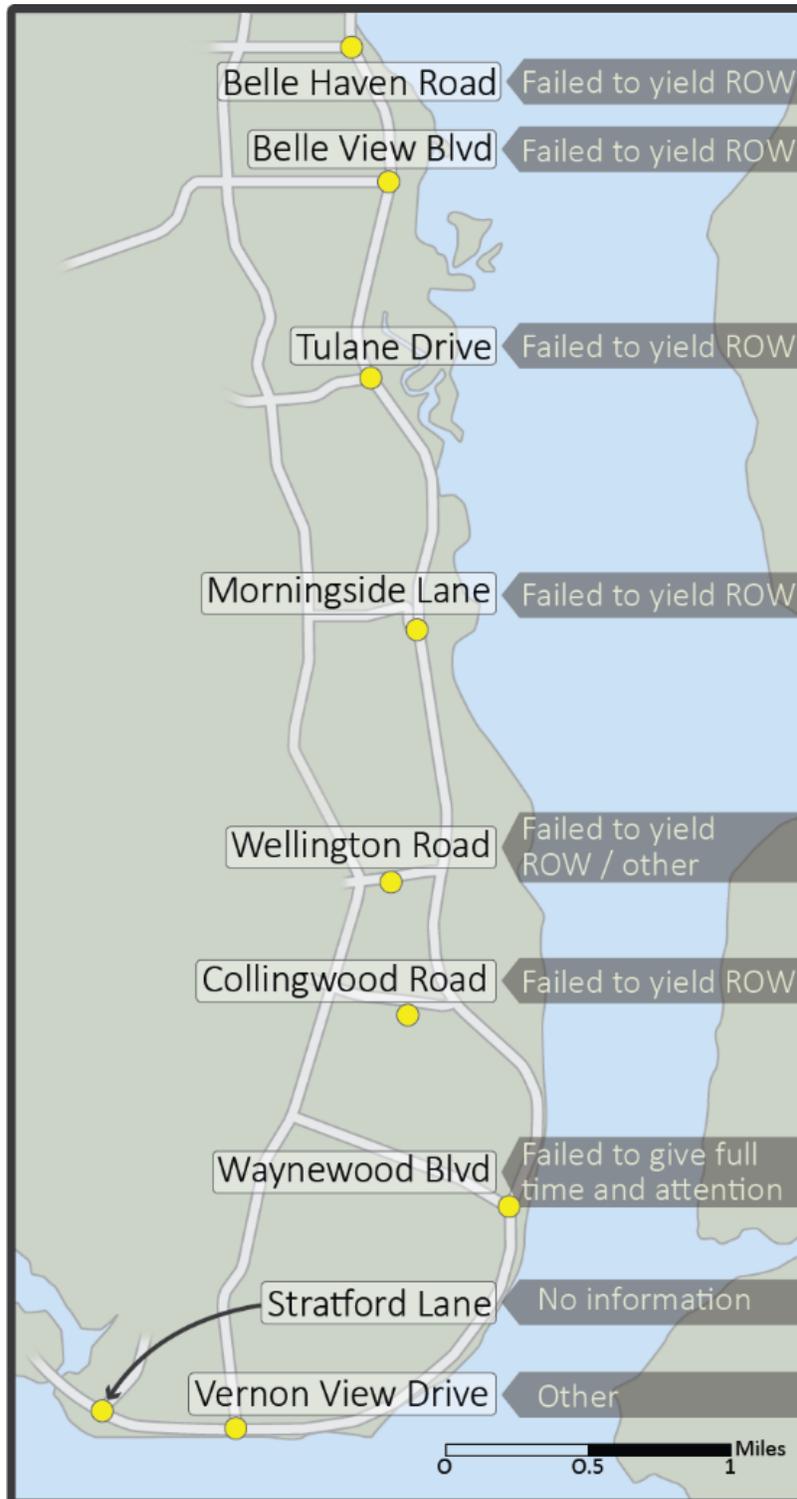
Figure 161. The South Parkway Corridor, Primary Cause

Overall, the primary cause reported most frequently in the corridor was “Failed to Yield ROW” (Figure 161). This suggests that either this is the primary cause chosen most frequently by those completing the crash reports or that there is a lack of clarity for drivers regarding ROW.

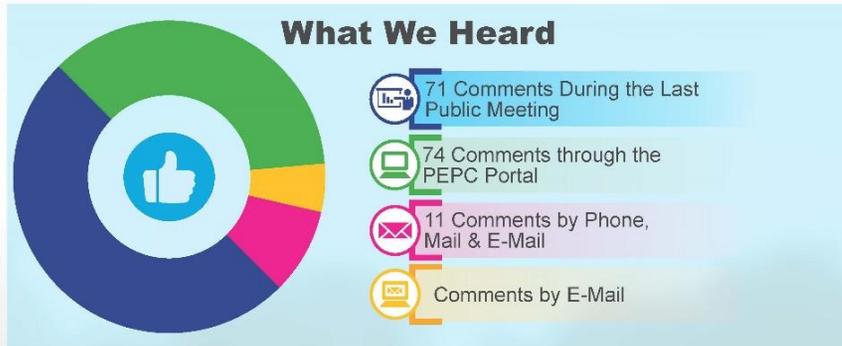
Figure 170. Feedback Received from the Second Public Outreach Meeting Held on December 3, 2019

The team collected 156 comments after the second public meeting, with 71 comment cards; 11 mailed letters, phone calls, or emails; and 74 comments posted in the PEPC portal. Figure 170 provides a summary of the comments received by topic area.

- 17% Roundabouts
- 13% Road Diet
- 25% Turn Restrictions
- 3% Centerline Buffer
- 6% Lighting
- 7% Pavement Markings
- 15% Bike/Ped Crossings
- 4% Education
- 10% Maintenance

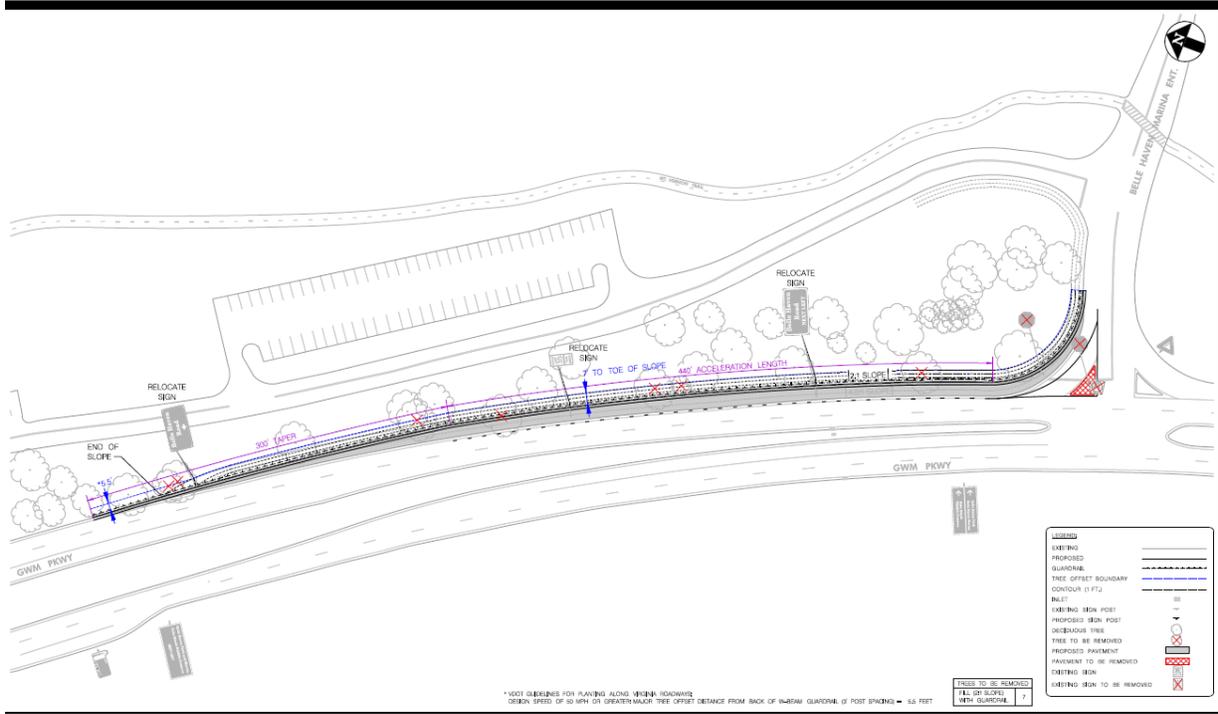
Figure 181. Example Belle Haven Marina U-Turn Acceleration Lane with 45 mph Design Speed

Figure 180 and Figure 181 illustrate the conceptual design of an acceleration lane to allow for the U-turn maneuver at Belle Haven Marina. A layout is shown for two design speeds — 35 mph and 45 mph. A higher design speed would require a longer acceleration lane, thus increasing the amount of impervious surface. Drainage would have to be installed. Some trees would have to be removed. The determination of acceleration lane length and full limits of disturbance need for retaining walls or other minor structures will be made based on a final determination of design and operating speeds for this segment of the Parkway.

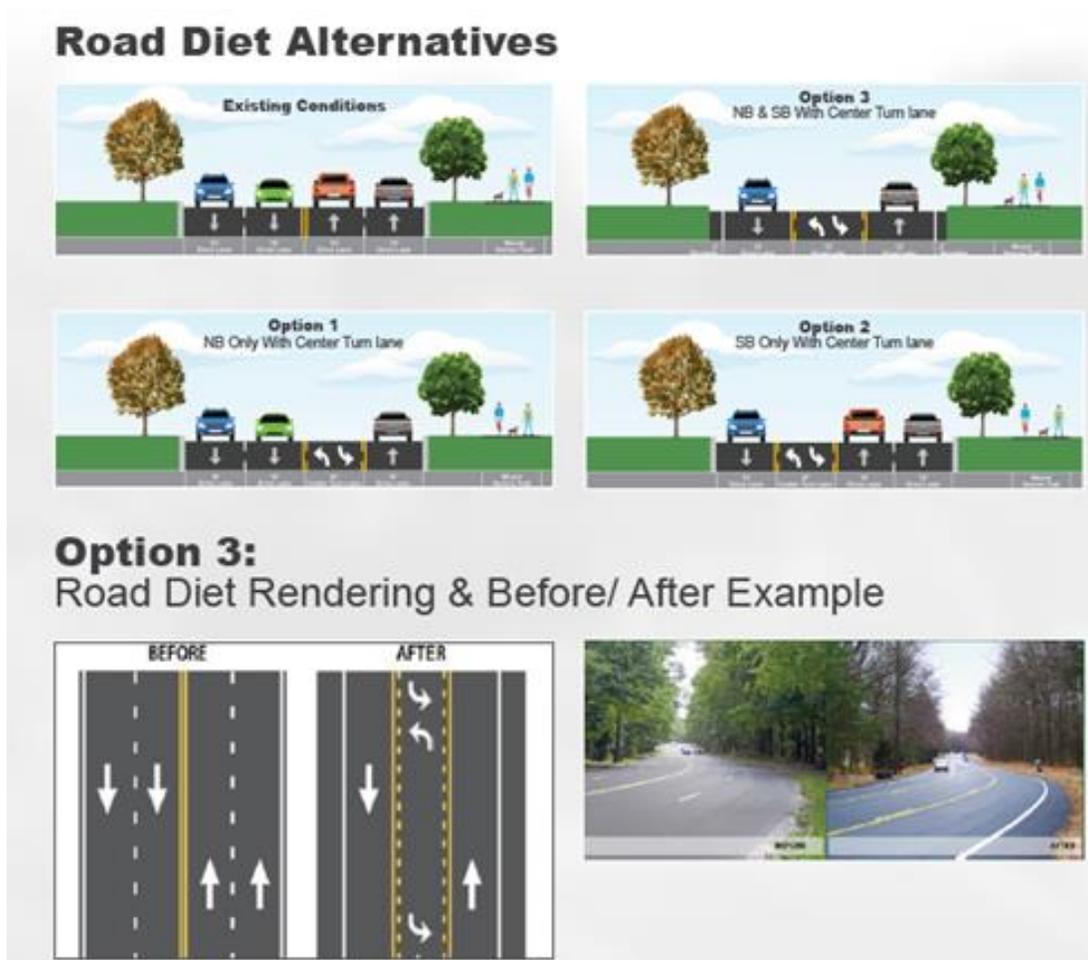
Figure 182. Example Road Diet Concepts

Figure 182 shows a graphical comparison of the only three practical configurations that would allow removing a travel lane and repurposing it as a turn lane. These configurations can be implemented on the Parkway where there is not currently a median.

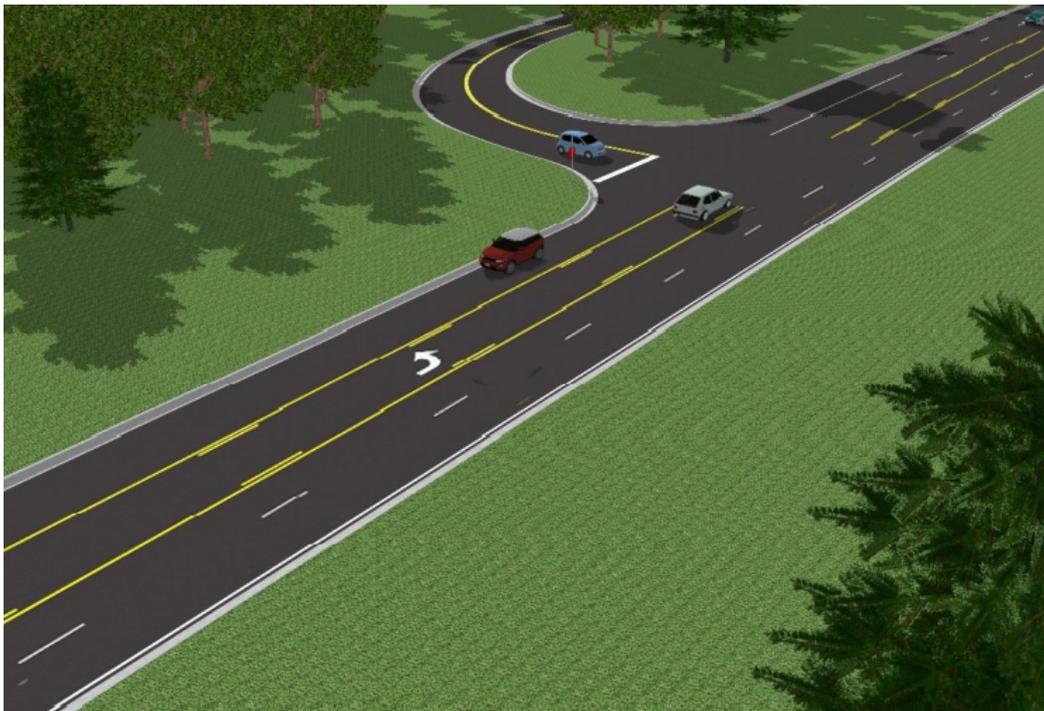
Figure 183. Example Rendering of Option 2 Road Diet at Morningside Lane

A rendering of a road diet treatment for option 2 at Morningside Lane is shown in Figure 183.

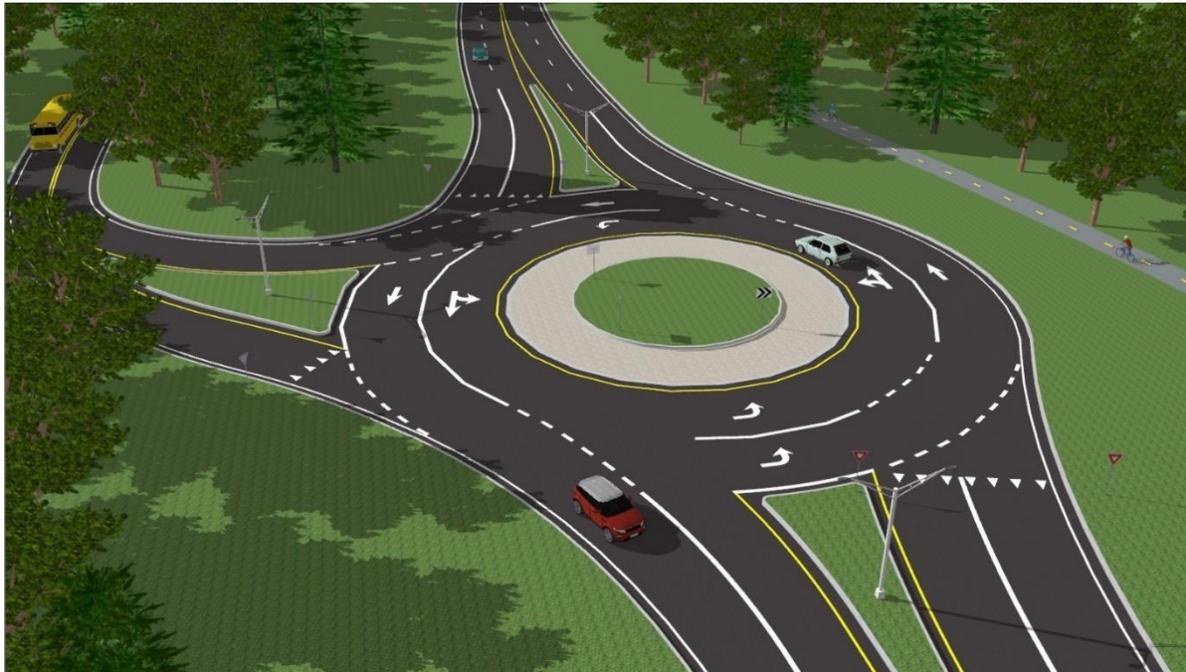
Figure 189. Conceptual Roundabout Rendering at Morningside Lane

A rendering of the roundabout at Morningside Lane is shown in Figure 189.

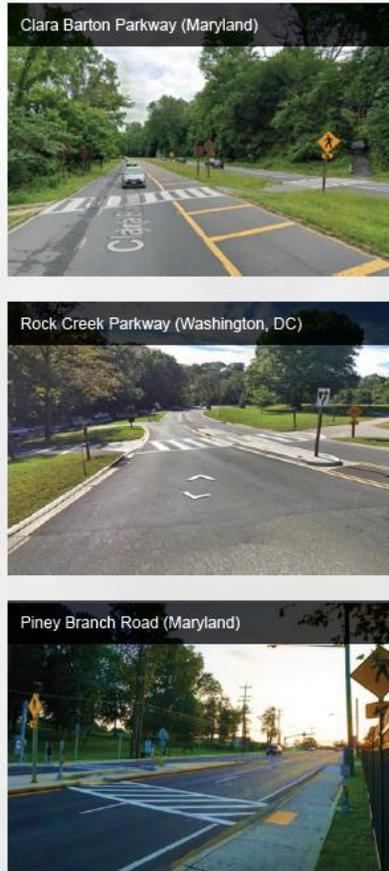
Figure 190. Enhanced Pedestrian Crosswalks (Street Views from Google Maps)

The refuge island is particularly helpful to pedestrians crossing multilane roads by breaking up the walking distance and allowing a respite from a quick walk across both directions of traffic. Crossing islands also alert drivers to the pedestrian refuge and encourage motorists to reduce speed. For refuge islands to be effective, their implementation on the Parkway would need to have complementary speed reduction countermeasures.

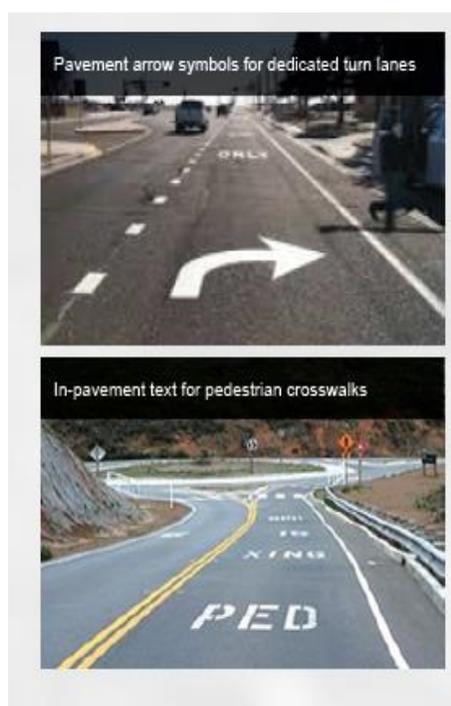
Figure 193. Examples of Pavement Symbols for Dedicated Turn Lanes and Pedestrian Crosswalks (Street Views from Google Maps)

Upgraded signing and pavement markings are key to providing guidance to motorists at decision points along the Parkway such as intersections, the Mount Vernon Trail (pedestrian/bicyclist), crossings, and entering and exiting auxiliary lanes (Figure 193). Ensuring that signs are updated with current *Manual of Uniform Traffic Control* standards such as W1-2 intersection warning signs, W11-15 (USDOT 2017) trail crossing signs, and advisory speed subplates will provide additional positive guidance to all motorists, especially park visitors.

Pavement markings could similarly be refreshed *routinely* and enhanced for visibility using high retroreflectivity grade tape and contrast tape to maximum conspicuity. Supplemental markings for auxiliary lanes could be installed, including right-turn and left-turn lane arrows and “only” verbiage, to provide positive guidance to Parkway motorists on auxiliary lane usage.

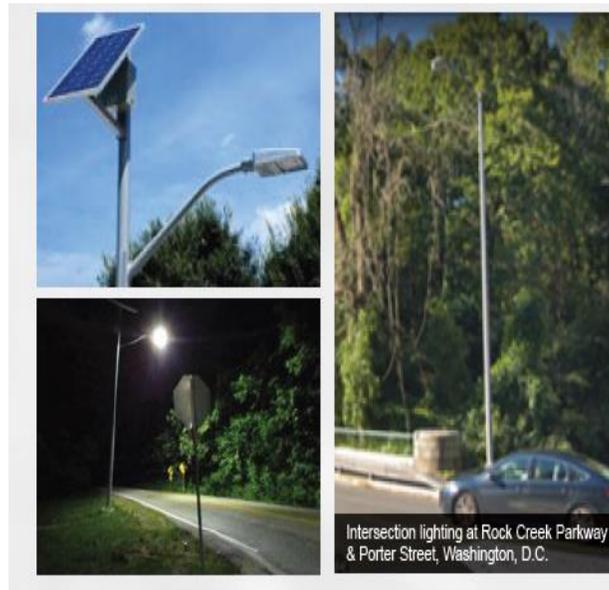
Figure 194. Intersection Lighting, At Night and with Solar Power (Street Views from Google Maps)

Intersection lighting refers to devices that illuminate the intersections at night. It does not include traffic signals. Pole-mounted intersection lighting provides appropriate illumination levels during dark hours for all conflict points within an isolated intersection to enhance visibility for motorists, pedestrians, and bicyclists (Figure 194).
