George Washington Memorial Parkway Traffic and Safety Context Sensitive Solutions Assessment

APRIL 2021

1. REPORT DATE • 7/31/2020	2. REPORT TYPE Final Report	3. DATES COVERED (<i>From - To</i>) November 2018 - July 2020	
4. TITLE AND SUBTITLE George Washington Memorial Parkway: Traffic and Safety Context Sensitive Solutions Assessment		5a. CONTRACT NUMBER DTFH71-13-D-00002L	
		5b. GRANT NUMBER: Task Order 693C7319F000010	
		5c. PROGRAM ELEMENT NUMBER

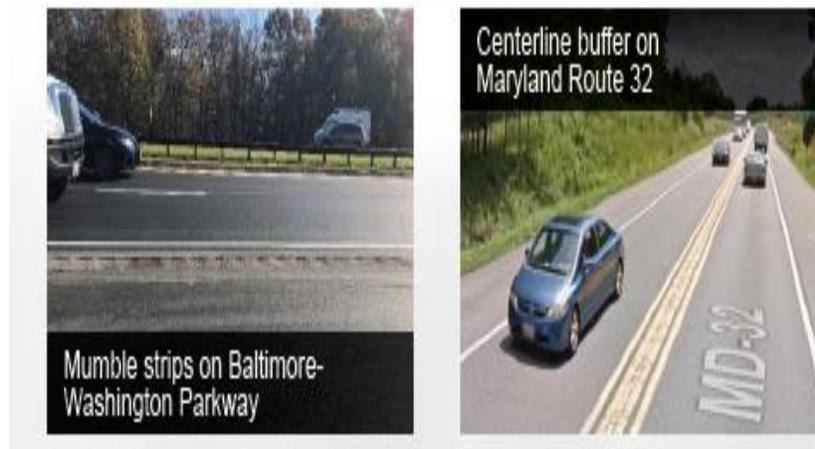
Figure 195. Centerline Buffer Area (Street Views from Google Maps)

departures. Rumble strips can also be used in the center of the roadway in coordination with a double yellow centerline to make drivers aware if they start encroaching in the opposite direction of travel. Mumble strips are still a relatively new treatment, as they have evolved from rumble strips with the intent of retaining the safety benefits while reducing the noise impacts. Figure 195 shows mumble strips on asphalt.

• **Centerline Buffer Area – Increase spacing between double yellow centerline and add mumble strips**

Rumble/mumble strips have been documented to reduce run-off-road, single-vehicle crashes by 10% to 16%, according to “**Install continuous milled-in shoulder rumble strips**” found in the FHWA CMF Clearinghouse (USDOT/FHWA 2020).

Mumble strips are recommended along the full length of the Parkway for the right travel lane. As there are numerous residences along the roadway, the mumble strips could bring safety benefits but provide consideration for these residences.

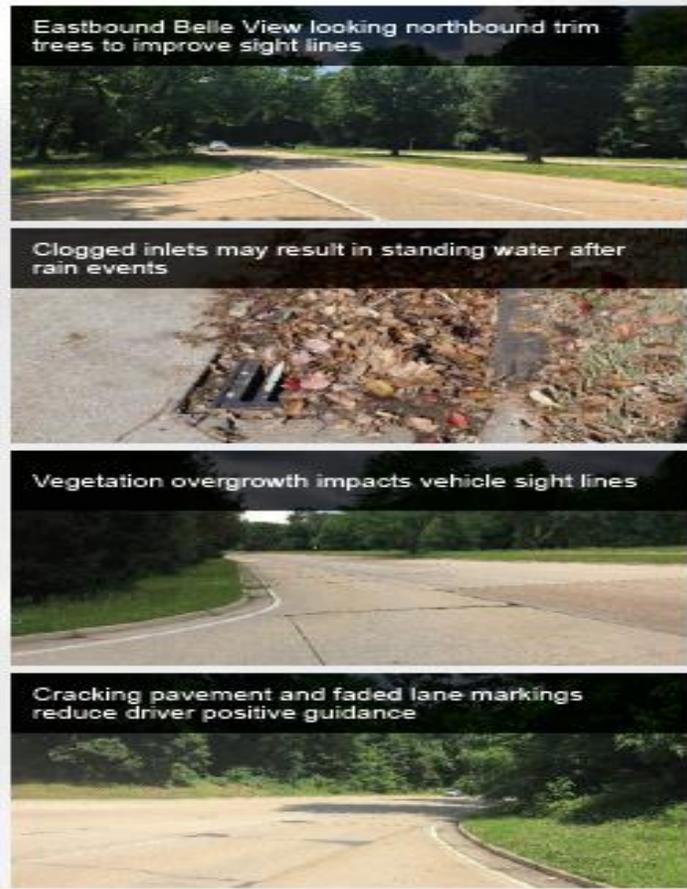
Figure 196. Roadway Maintenance Examples (Street Views from Google Maps)

Roadway maintenance plays a key role in improving traffic safety. Important measures for improving traffic safety on the Parkway (Figure 196) include:

- Routine maintenance of vegetation to maintain intersection sight lines
- Clearing of storm drain inlets from debris to maintain storm water runoff and reduce standing water
- Repairing roadway surfaces such as potholes
- Refreshing faded pavement markings

Roadway Maintenance

- Tree Trimming
- Cleaning of Drop Inlets
- Repair Roadway Surface
- Repainting Pavement Markings

Specifically, maintenance activities could provide a sight distance of at least 590 feet, which corresponds to vehicles traveling 50 mph, to accommodate intersection sight distance for prevailing vehicle speeds. (*Note:* The sight distance can be reduced as engineering and enforcement solutions are implemented to assist with traffic calming (e.g., speed reduction).)
